Maryland Historical Trust
State Historic Sites Inventory Form

Survey No. B-4376

historic 105-107-109 West Saratoga Street

and/or common HCH Clinic/Dr. J. Breshkin/vacant

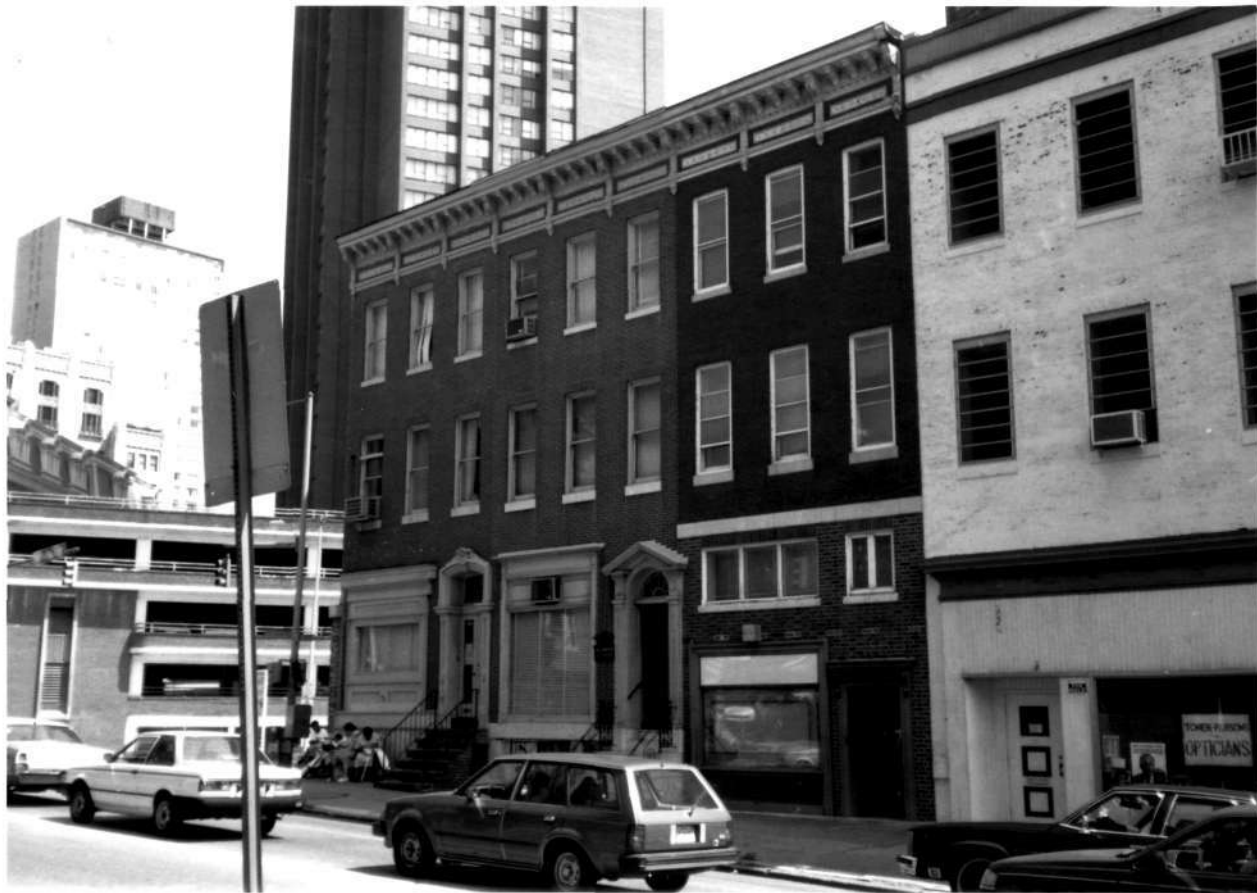
1/6

Facade, north elevation

This circa 1875 brick building is sits on the southwest corner of West Saratoga Street and Liberty Street. The three-story, nine-bay building is subdivided into three three-bay units with mixed commercial and residential use. The absence of a seam in the brickwork between the units coupled with the even fenestration pattern and continuous cornice indicate that the three units were built as a single row. The far west unit abuts a partywall structure to the west. The total street frontage of the building is 51'.

The second and third stories of the nine-bay building have nine evenly spaced 1/1 sash windows with brick splayed jack arches and stone sills.

The cornice of the shed-roof structure is a projecting one. The profile consists of fillet, ogee, a tiny dentil course (only present in the middle three bays) and back band. Curved modillions with rosettes run below. This is followed by a jig-sawn back band with a drilled dentil course. Ten large embellished brackets have extended legs that drop down to divided the nine bays. These brackets are embellished with dots, leaf pendants and rosettes. An ornate stringcourse runs between the feet of the brackets. Each "spandrel" has jig-sawn attic ventilator panel.

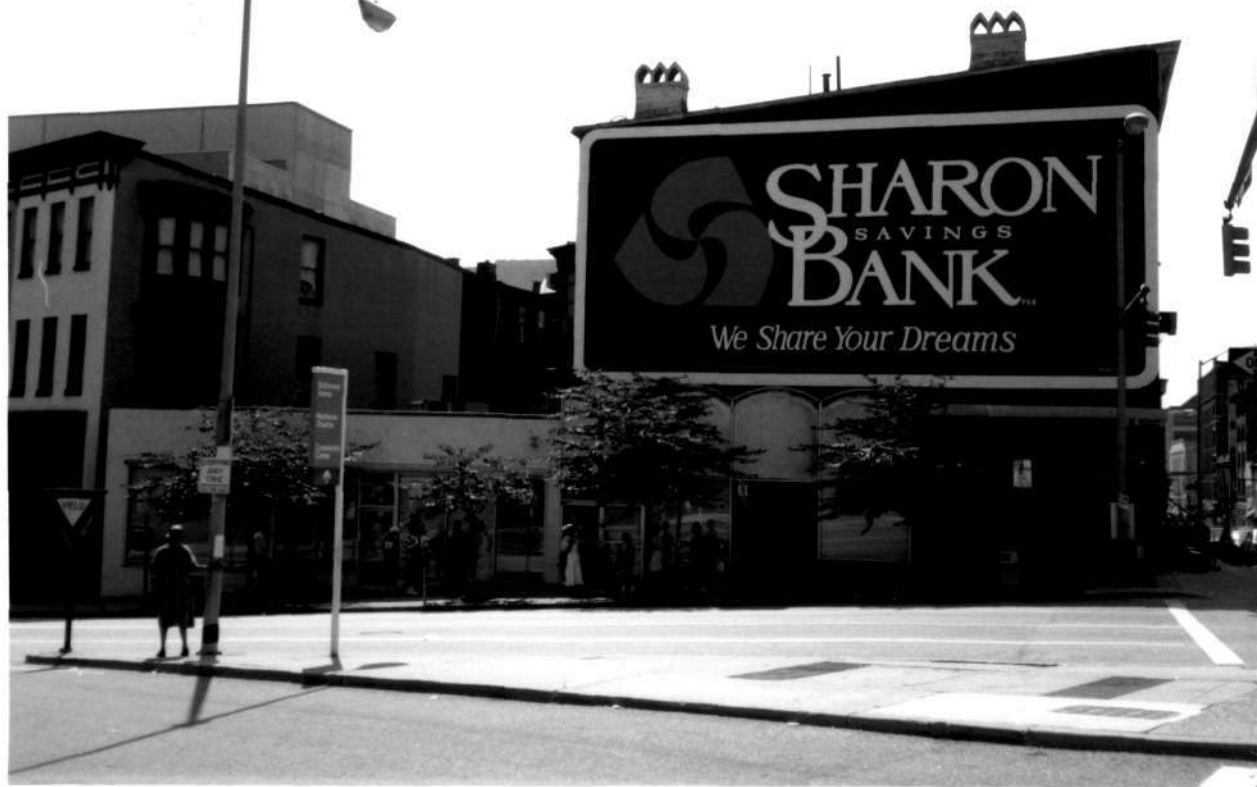
2/6

East elevation plus addition

The west wall of the corner unit faces Liberty Street. This facade consists of two buildings, the main building and a late 20th-century addition. The main building has been covered with circa 1960s formstone. Windows and doors have been cut into the first story. Their 1960s architectural surrounds usually link them to the addition. A pair of glass double doors abuts the south edge of the wall. A display window abuts the door, followed by a blank bay, followed by a display window. Four arched giant transoms (now blocked) span the doors, window, blank bay and window. The openings are set in metal frames. The upper stories are parged. Two brick chimneys rises along the south and north ends.

The addition is a one-story brick building built into the slope of the sidewalk. It is an enframed window wall design of nine windows set into a brick wall. The sixth opening is actually a glass door and not a window. The first six openings have transoms. The seventh, eighth, and ninth windows are full length without transoms. The brick is painted white.

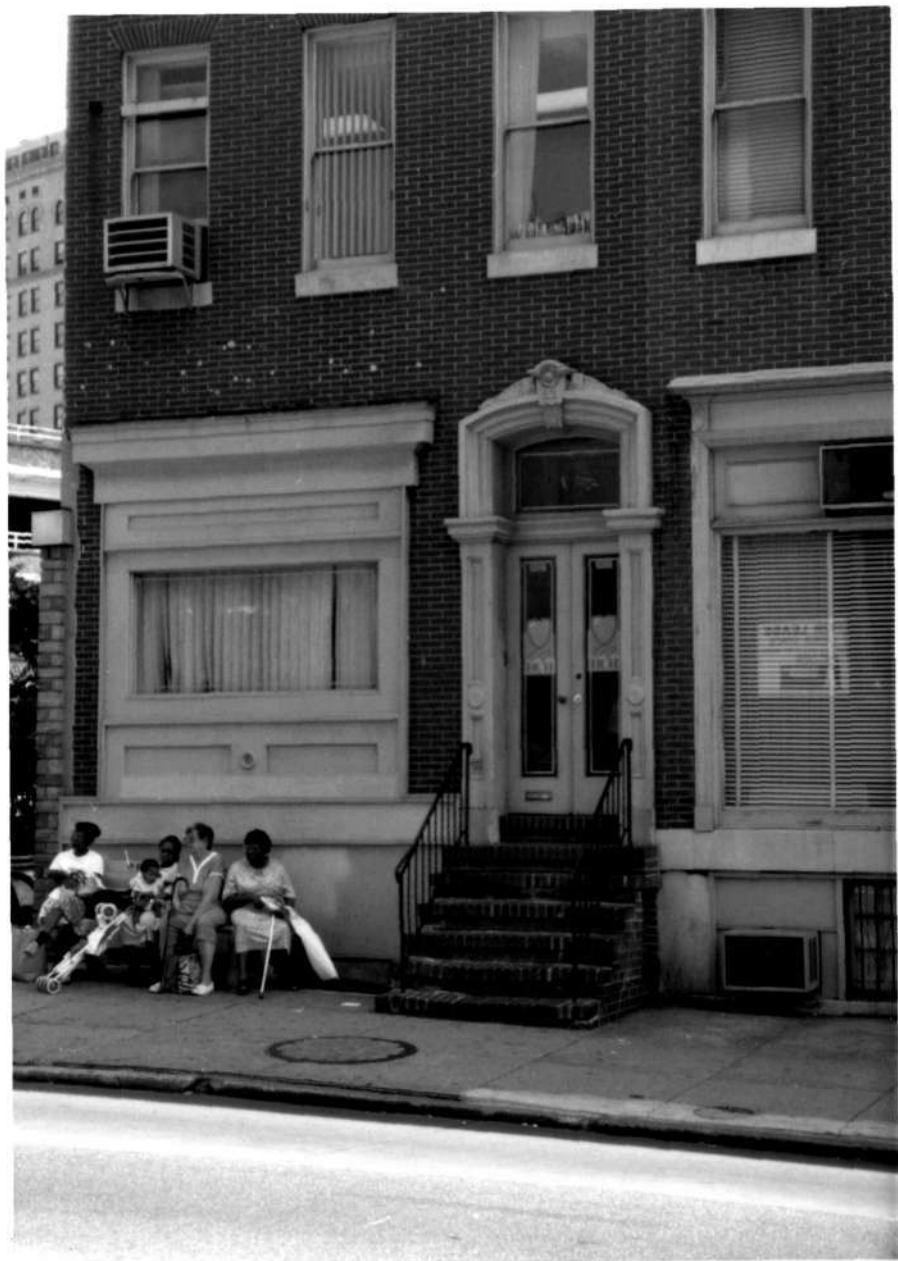
3/6

Facade, detail

The east corner unit (#105) has a display window in the first two bays and an entrance in the third. The first story is set above a wood-sided raised foundation. The display window has an ornate architrave. Two recessed field spandrels are positioned under the window and one recessed field spandrel runs above the window. A simple lintel of two corbelled back bands with raised molding and another back band surmounts the top spandrel. The inset entrance is in the third bay and is reached by a flight of six brick steps. The outer door is a 19th-century narrow double door with long panels of glass inset into wood frames. The Italianate outer door surround is made of cast iron. The recessed field pilasters have rondel embellishments and the projecting hood has a cast iron keystone composed of a medallion and acanthus leaf that are bracketed by crests on either side. The interior of the vestibule contains two doors. The door to the east opens into the first-story store front. The door to the south opens into a stair hall. The door to the south has milled wood jambs and a transom. The vestibule is finished with wainscot panelling.

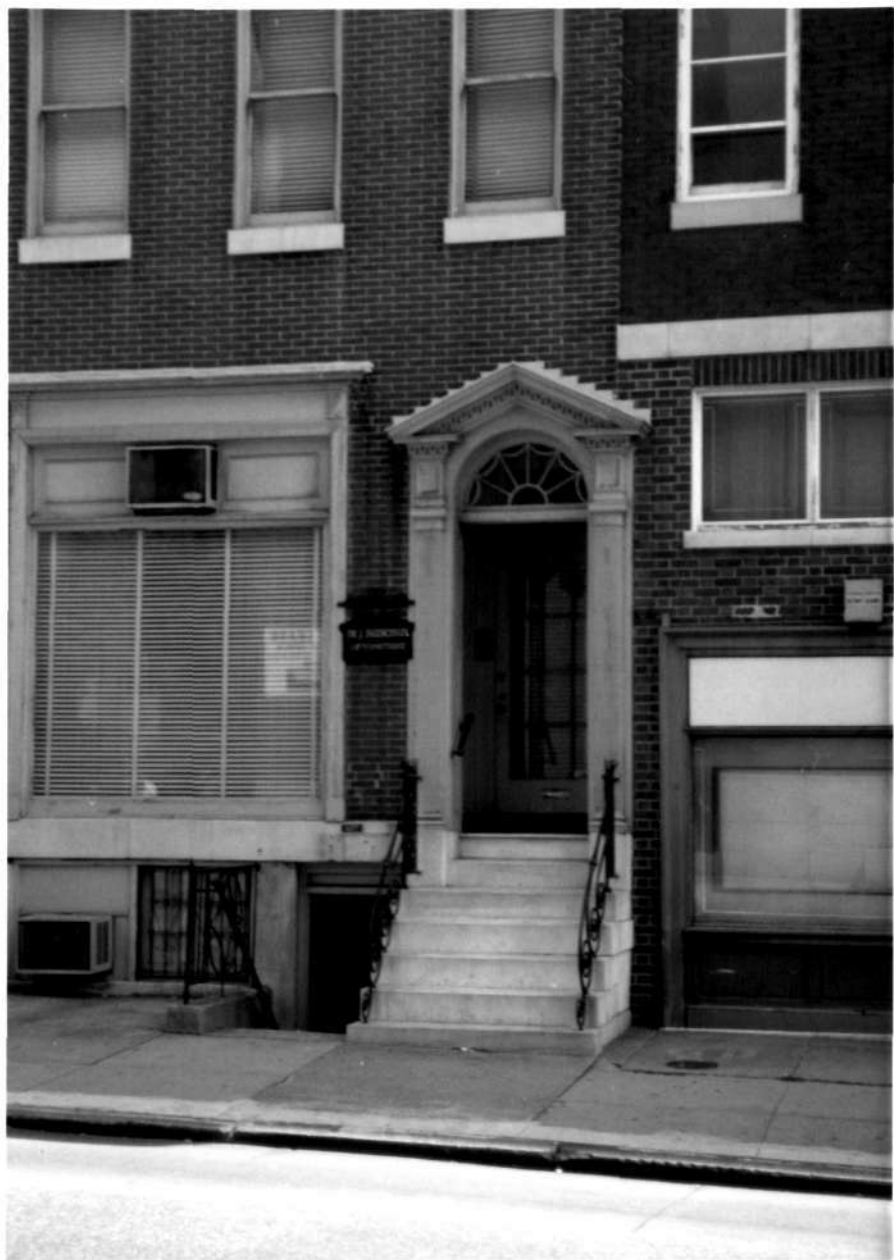
4/5

Facade, detail

The first story of #107 has a similar facade as #105, with a display window in the first two bays and an inset entrance with an ornate cast iron surround in the third. The first-story is set upon a raised foundation. The large plate glass display window is set in a milled wood architrave. The original tripartite transom is now filled with three solid panels. The lintel is supported by a back band with end blocks with a raised starburst design. The door is reached by seven marble steps. The cast iron surround is a Greek Revival style, with fluted pillars topped by metopes support a gabled pediment. A drilled dentil course runs along the bottom edges of the pediment. The outer door is missing, but the transom remains with its radiating filigree comes. The interior of the vestibule contains two doors. The door to the east opens into the first-story store front. The door to the south opens on to a stair hall. Both doors are modern, 12-light doors with original milled wood jambs. The south door has a transom.

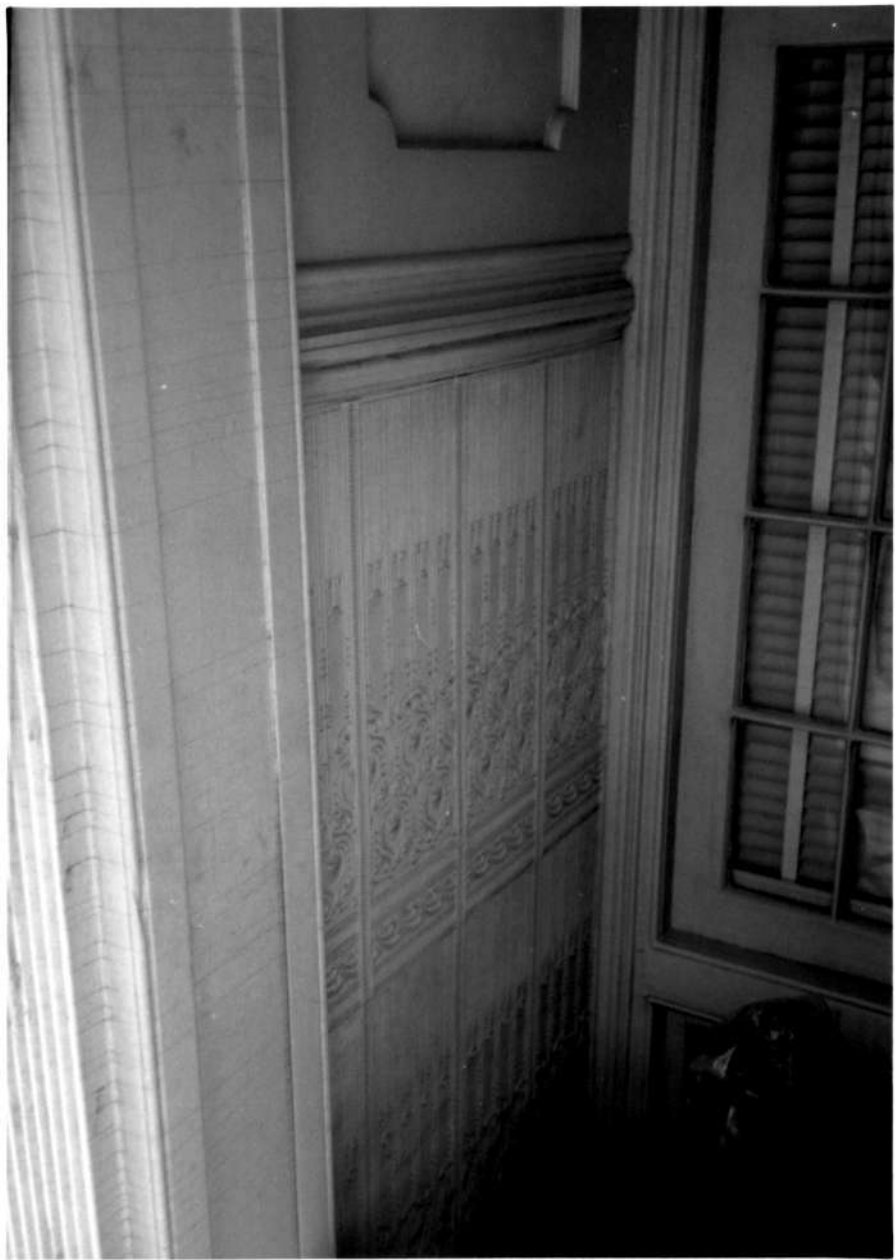
5/6

Facade doorway detail

The vestibule floor is laid with brown and white hexagonal tiles and a green and white Greek key frieze. The walls are papered with Lincrusta. The raised foundation wall has two cellar windows and a separate cellar entrance reached from the sidewalk.

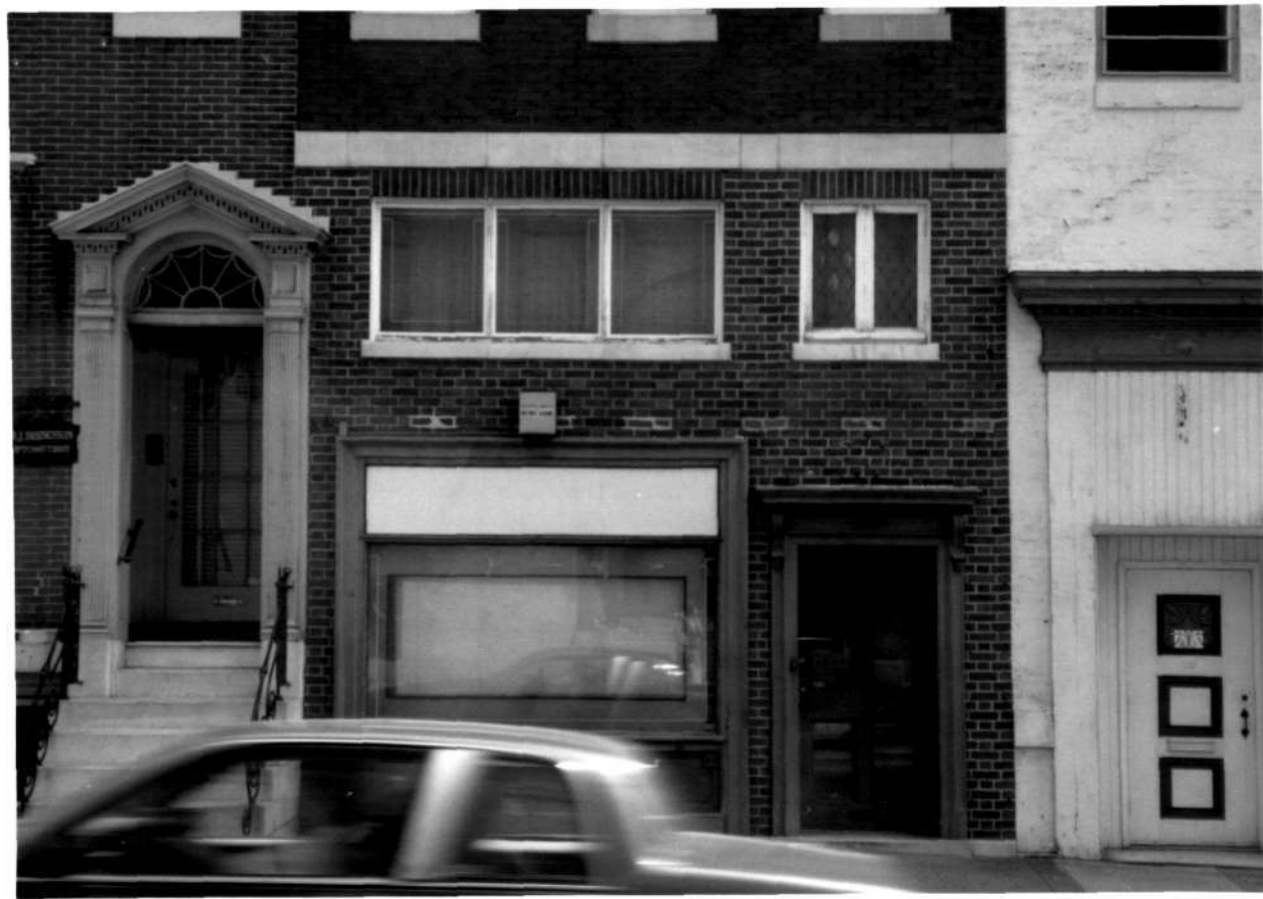
6/6

Facade, detail

The first story of #109 is substantially altered. The wall has been relaid in 20th-century flemish bond brick. Instead of having a first story built upon a raised cellar, this facade has a ground level first story with a mezzanine level above. A display window is in the first two bays. It is set in a wood surround with raised molding. There are three decorative panels below the window and a now-blocked transom above. The entrance is in the third bay. The door has 6 lights. The surround is narrow pilasters topped by brackets that support an overhanging shelf cornice. The mezzanine has three single sash windows abutting one another in the first two bays and a leaded diamond-paned casement window in the third bay. The windows have stone sills. A stone stringcourse divides this story from the second story.
